# Manhole Inspection Summary

Manhole # S19I\_\_029MH

Insp Date: **3/4/08 10:02 AM**

**Location** Address: **31 calverton-smallwood alley**

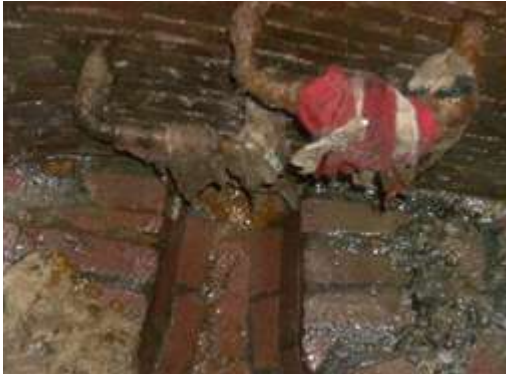
Defect 2

☒ Evidence Of Surcharge Depth: **4** (ft.) ☐ Active Surcharge Present

surcharge evidence on the steps

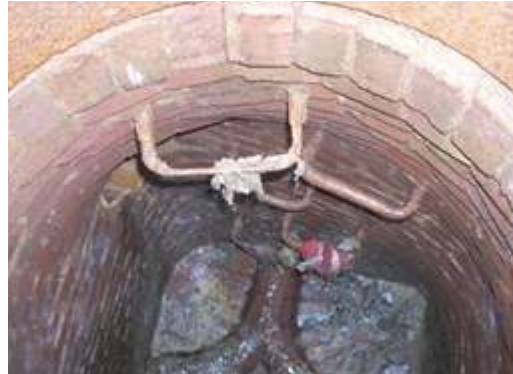
Defect 1

Count: **5** Missing: **0** ☒ Corroded

corroded steps

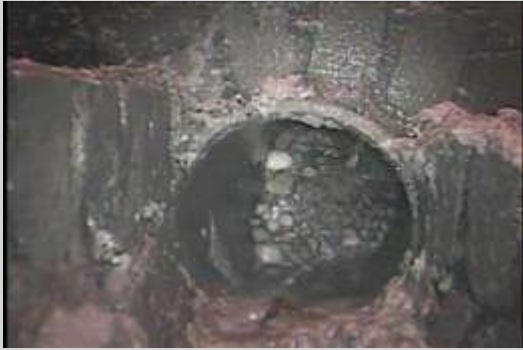
8 O'Clock Inflow

abandoned pipe at I8

Deposits: ☐ None ☐ Mud ☐ Sludge ☒ Debris ☐ Grease

Silt Depth: 0 (in.) Deposits Extent: Light

Connects To: Stub connection / abandoned
